# REVISED FINAL REMOVAL ACTION COMPLETION REPORT SAN JACINTO RIVER WASTE PITS SUPERFUND SITE

May 2012

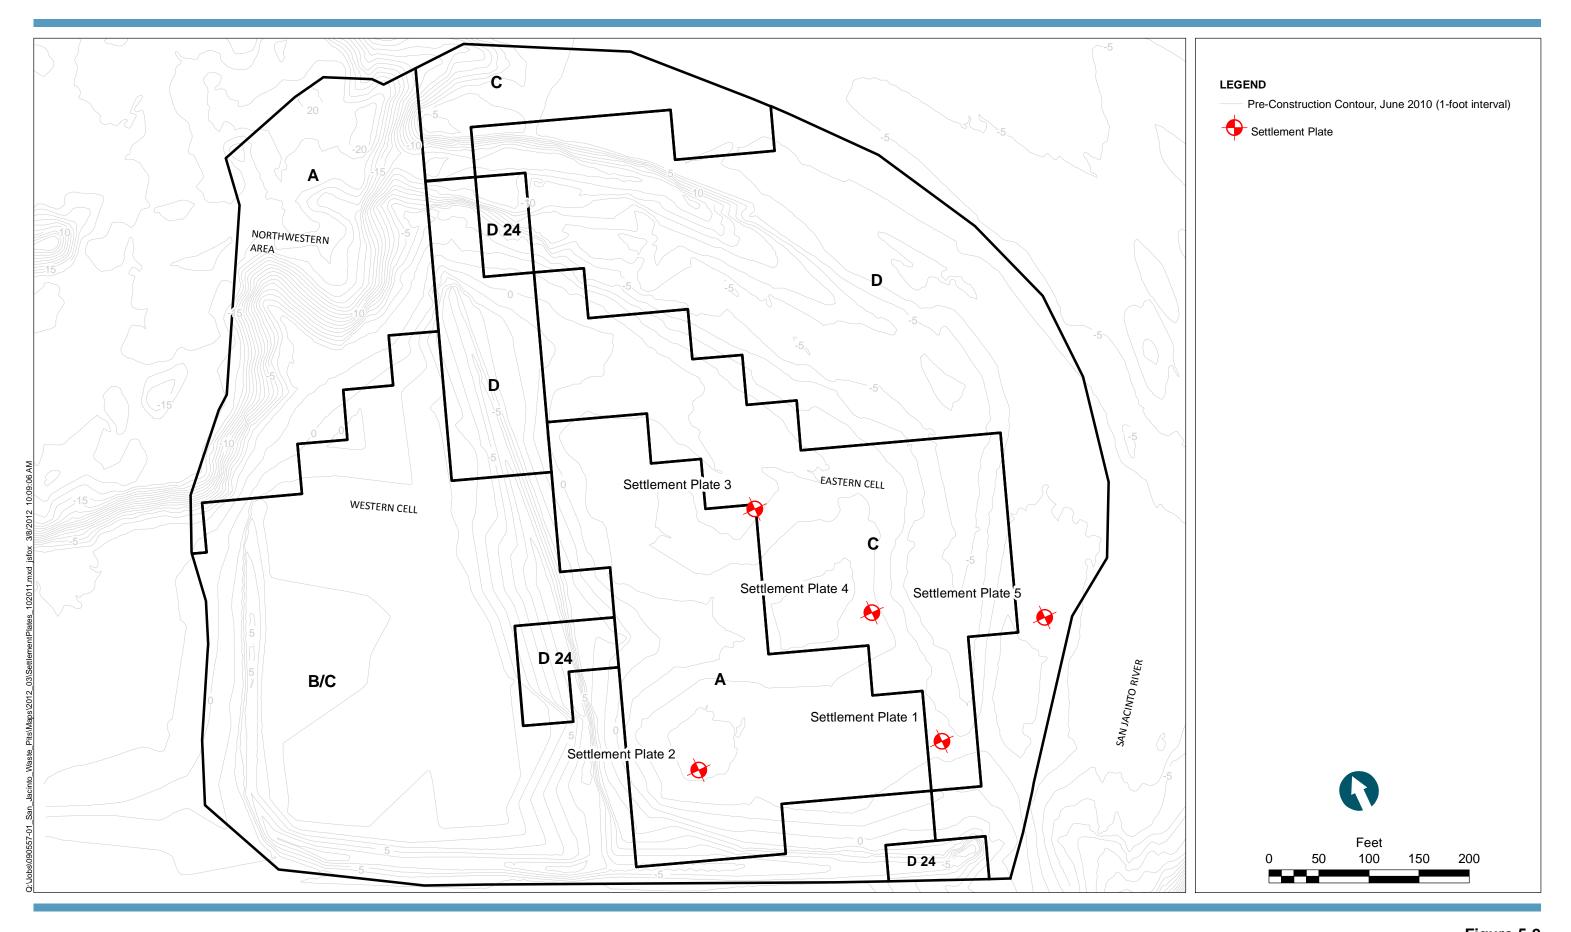
Figure 5-2
Settlement Plate Locations
Removal Action Completion Report
San Jacinto River Waste Pits Superfund Site

These plates were installed by CRA beginning on April 27, 2011. Survey data collected from the settlement plates is provided in Table 5-1; these data indicate that the weight of the armored cap caused cumulative settlement of approximately 1 to 6 inches in the Eastern Cell.

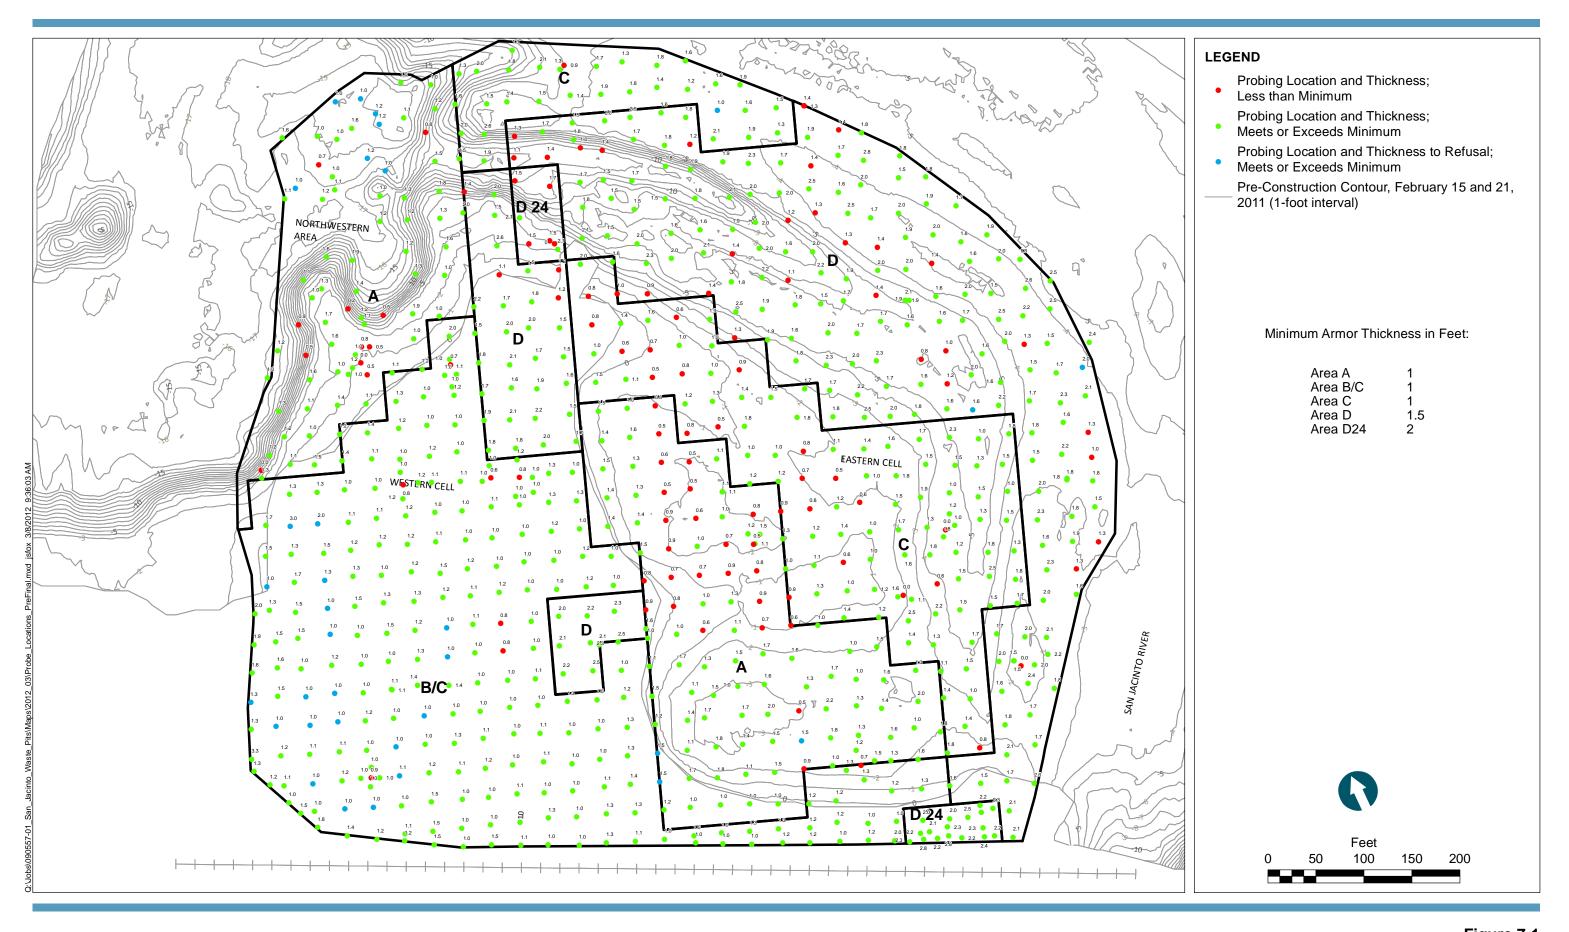
Figure 7-1

For each manual probing location, the surveyor collected a top-of-rock elevation. Then, a crew member used a section of rebar to penetrate through the aggregate layer until the underlying geotextile was reached (in the Northwestern Area, the rebar was pushed through the aggregate layer until resistance to probing was minimal, indicating that the rebar had penetrated through the aggregate to the softer underlying sediments). Once the bottom of the aggregate was identified, the depth of the rebar was noted, and the rebar was retrieved and placed on the top of the aggregate, and the depth of the rebar was noted again. The thickness of the aggregate, defined as the difference between the rebar depth from the bottom of the aggregate and the top of the aggregate, was recorded by the surveyor along with the global positioning system (GPS) coordinates of the probed location.

Manual Probing Pre-Final Survey
Removal Action Completion Report
San Jacinto River Waste Pits Superfund Site
